**Fire Resistance Test in Accordance
with BS EN 1634-1: 2000, on a Horizontal
Sliding, Accordion Type Doorset
within a Partition**

Won-Door Corporation

Report Issued : 6th November 2001

Date of Test : 28th June 2001.

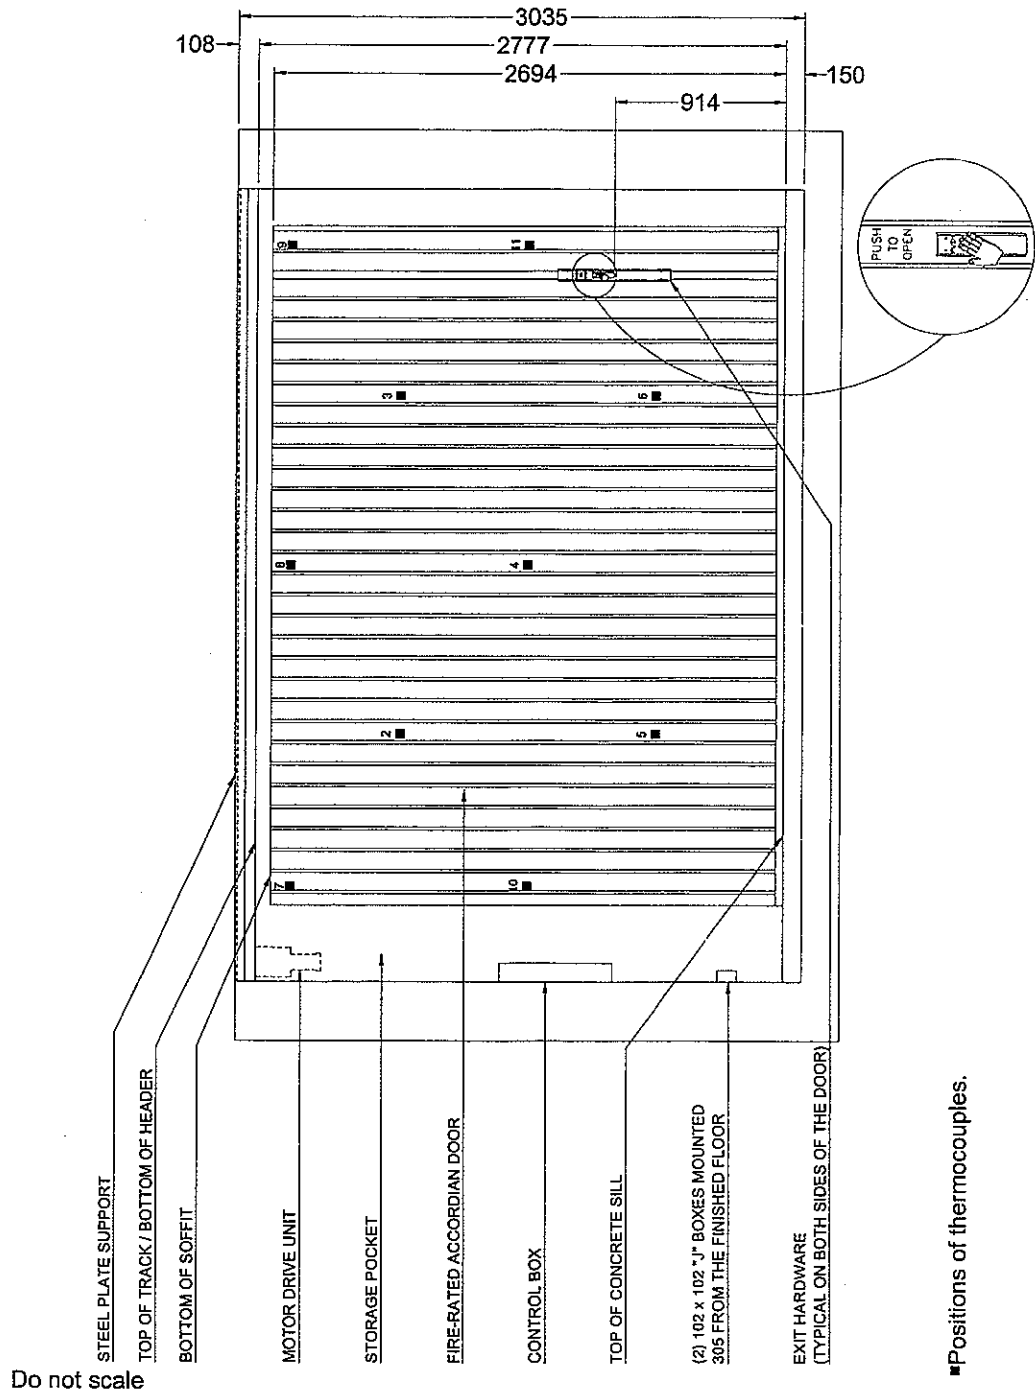
FIGURE 1

All dimensions are in mm.

- 4.4.3 The locations and reference numbers of the various unexposed surface thermocouples are shown in Figure 1 of Annex A.
- 4.5 Photographs of the specimen taken before, during and after the test are included in Annex D.

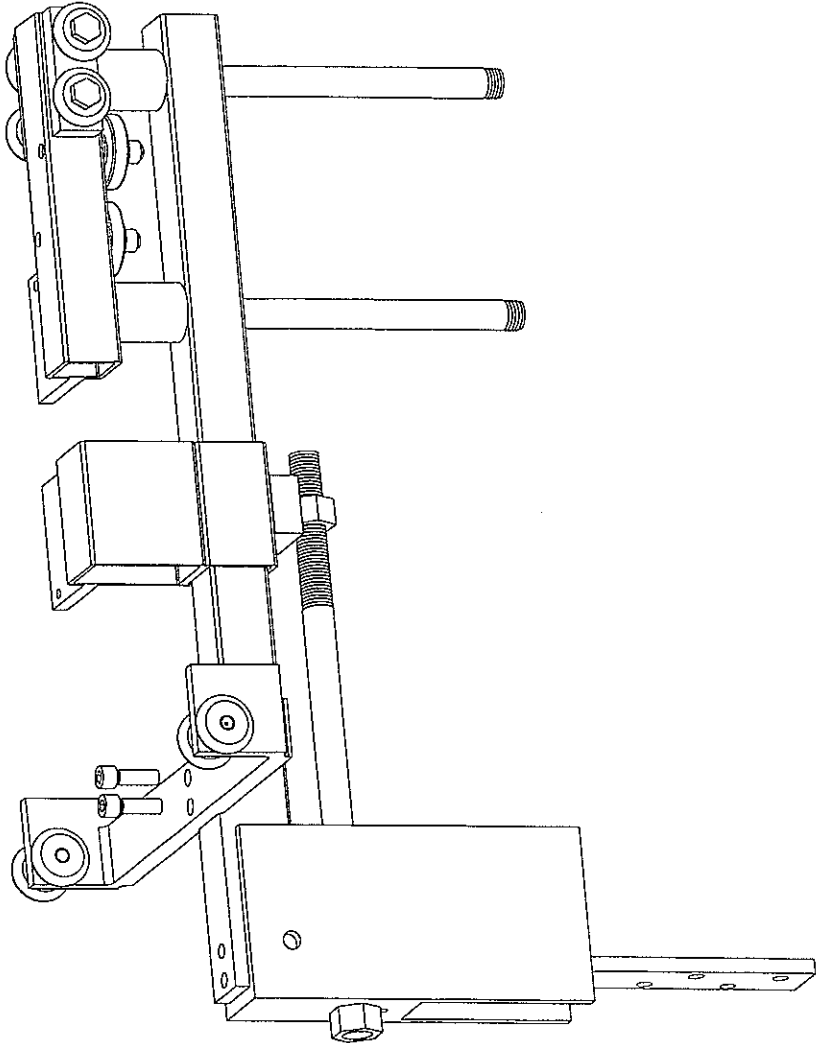
FIGURE 6

DETAIL OF T-05 OUTRIGGER
TROLLEY ASSEMBLY
